Contrasting Fluvial Geomorphic Processes and Historic Change Through Time: Supporting Watershed Management in Tributaries of the Napa River Watershed

Sarah Pearce¹, Robin Grossinger¹, Matt O'Connor², and Lester McKeel¹ ¹ San Francisco Estuary Institute, Oakland, CA ² O'Connor Environmental, Inc., Healdsburg, CA

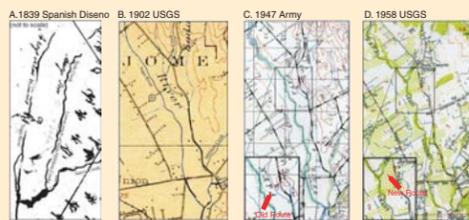
This historical map series highlights the changes that have occurred at the junction of Soda Creek with the Napa River.

- The historical record suggests that the interaction between Soda Creek and the Napa River has been highly dynamic, probably both as a result of natural process and human activity. In general, the trend in the past 60 years in this system has been one of channel simplification. Evidence suggests that Soda Creek has been disconnected from its historical drainage system by the removal of an approximately 600 m (2000 ft) section of stream channel.

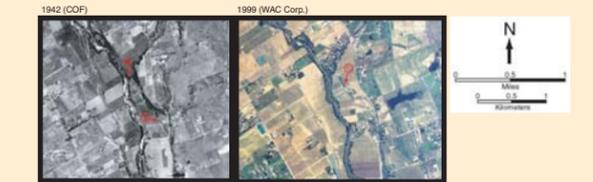
The first aerial photography available for Napa was produced in the early 1940's and shows further evidence of a direct connection between Soda Creek and the Napa River. It is a fairly straight connection, with riparian overstory substantially narrower than the route to the southeast. (a) new route, (b) old route.

- This change in channel location has ramifications for the entire subwatershed, including loss of low gradient stream channel salmonid habitat, potential downcutting by Soda Creek at this location as it adjusts to the new local baselevel, increased flood hazards, and a greater connectivity for sediment delivery to the mainstem Napa River.
